SAN FRANCISCO BAY NAVAL SHIPYARD  
SAN FRANCISCO, CALIFORNIA 94135

From: Commander, San Francisco Bay Naval Shipyard  
To: Distribution List  
Subj: Report entitled "Health Physics Activities in Connection with the Disestablishment of NRDL: Disposal of Radioactive Material and Termination of AEC Licenses"; forwarding of  
Encl: (1) NRDL Report "Health Physics Activities in Connection with the Disestablishment of NRDL: Disposal of Radioactive Material and Termination of AEC Licenses" of 31 Dec 1969.

TABLE OF CONTENTS

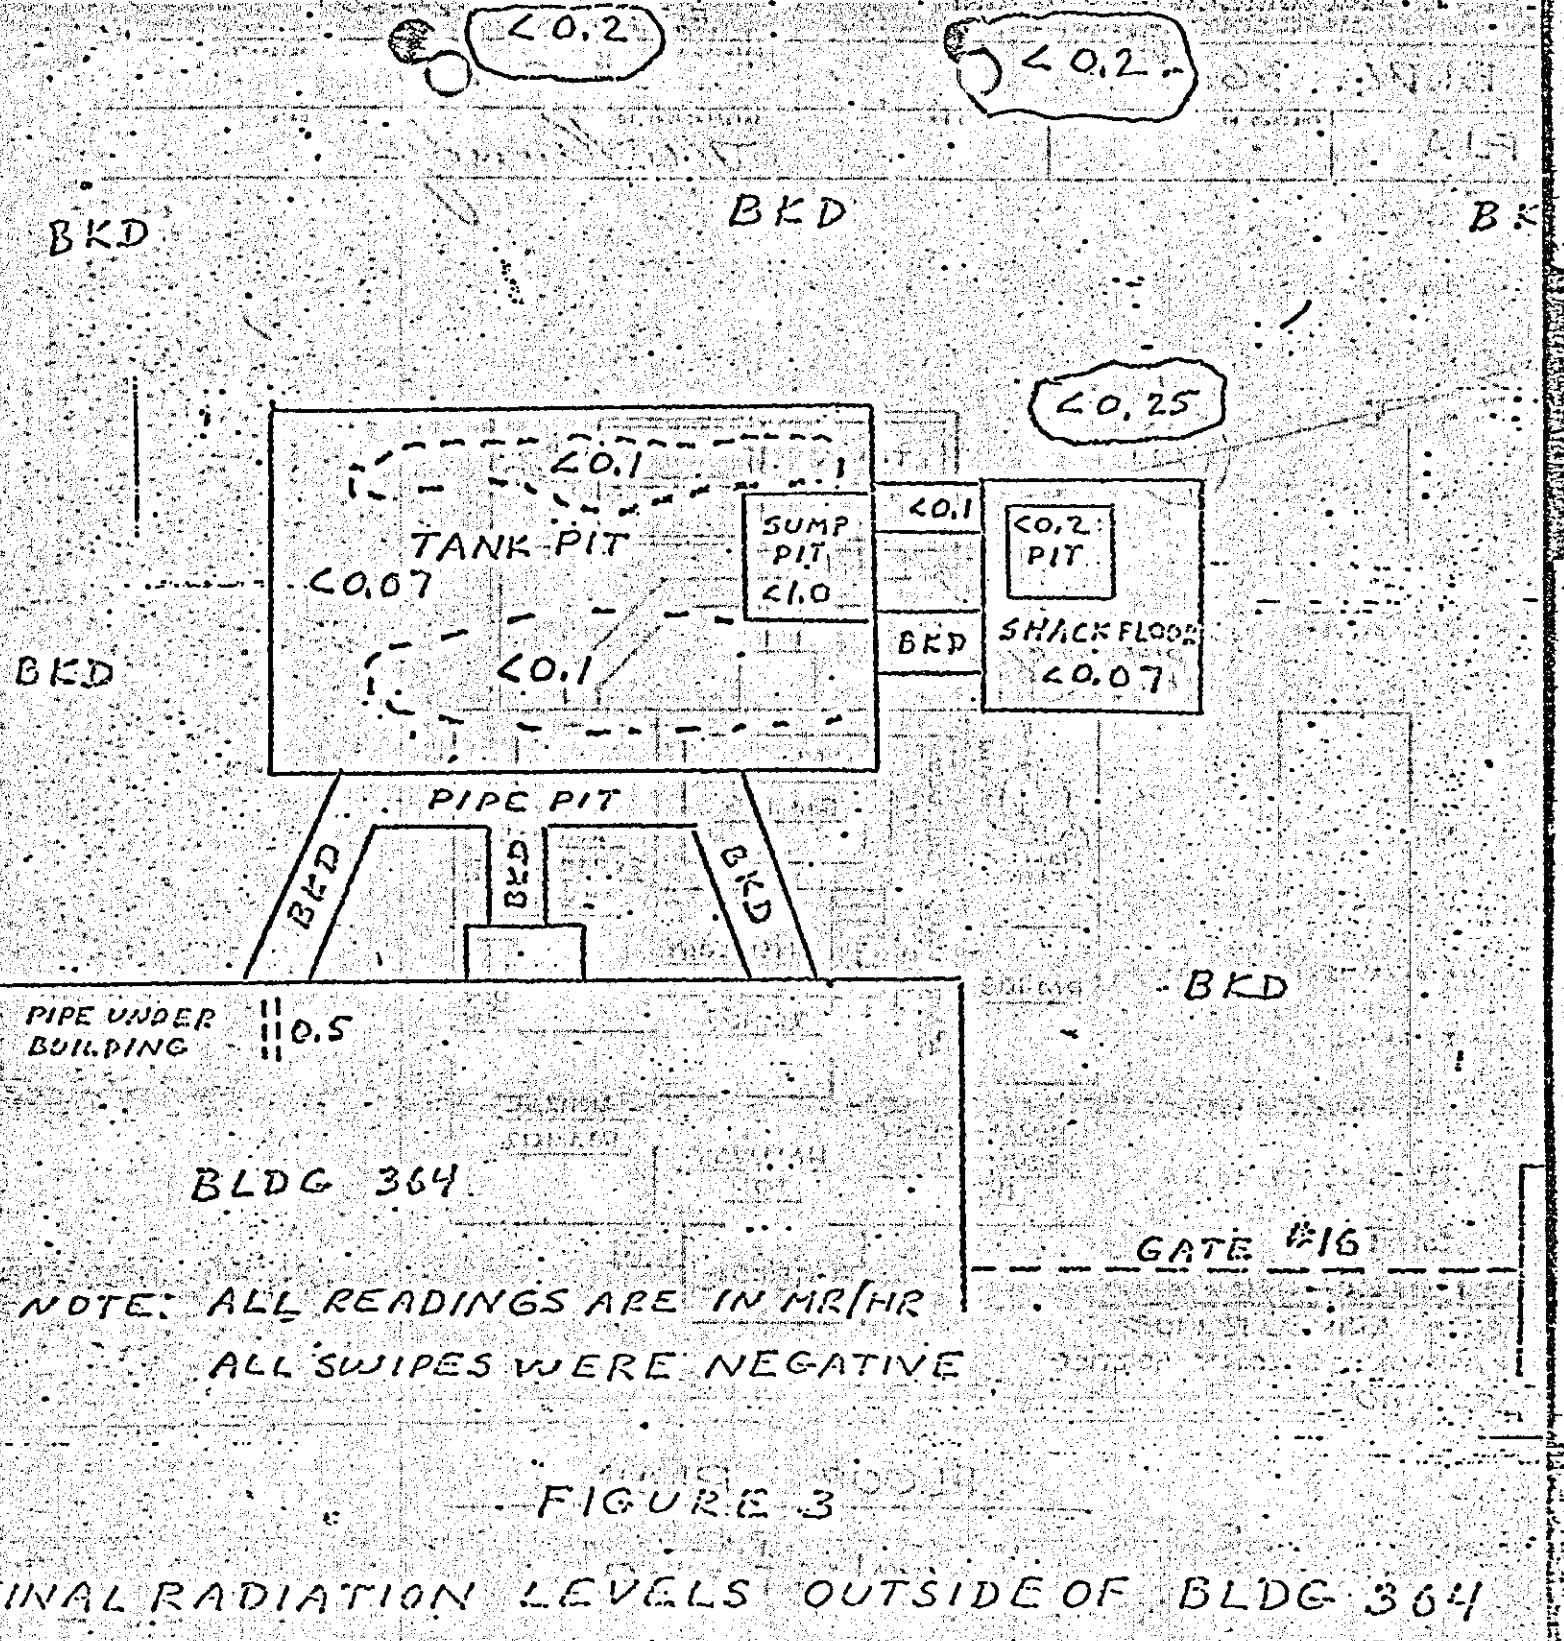
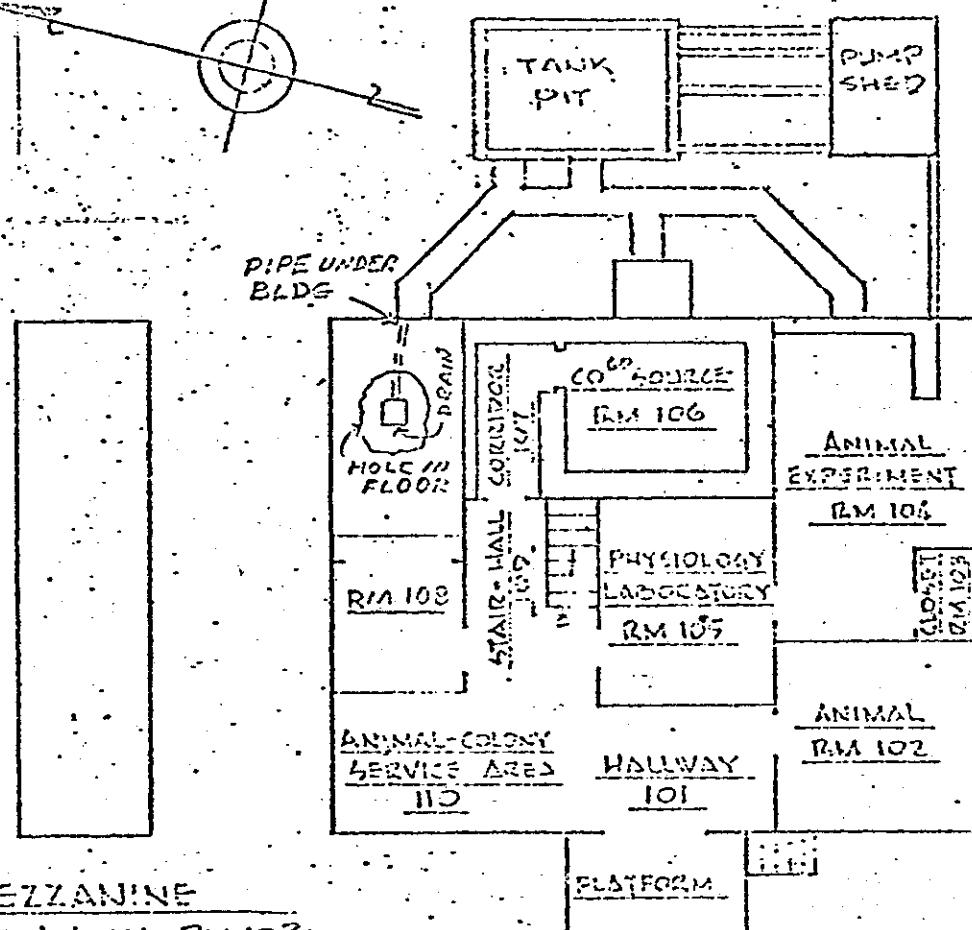
FIGURE 4

All plumbing from Bldg 364 to the tank pit was removed. One piece of pipe going into a concrete slab under the building read 0.5 mr/hr. The other end of the pipe connected to Room 108, originally the decontamination room. The drain which was several feet below floor level had been covered up with sand and a top layer of concrete. In order to determine radiation levels on this end of the pipe, the floor was broken and the sand removed from the drain sump. Location of the drain is shown in Figure 4. Radiation levels on the bottom of the drains were a maximum of 0.07 mr/hr. Following discussions with the AEC it was decided to leave the pipe in the concrete slab. However, their recommendation was that the hole be filled in. This presented no problem since the shipyard had already stated that the concrete floor was to be restored. Some contamination was also detected on the walls of Room 108; this was readily removed by washing down with detergent and water.

Radiation surveys and swipes were made in the remaining rooms of the first floor and mezzanine (see Figure 4). No detectable radiation was found.

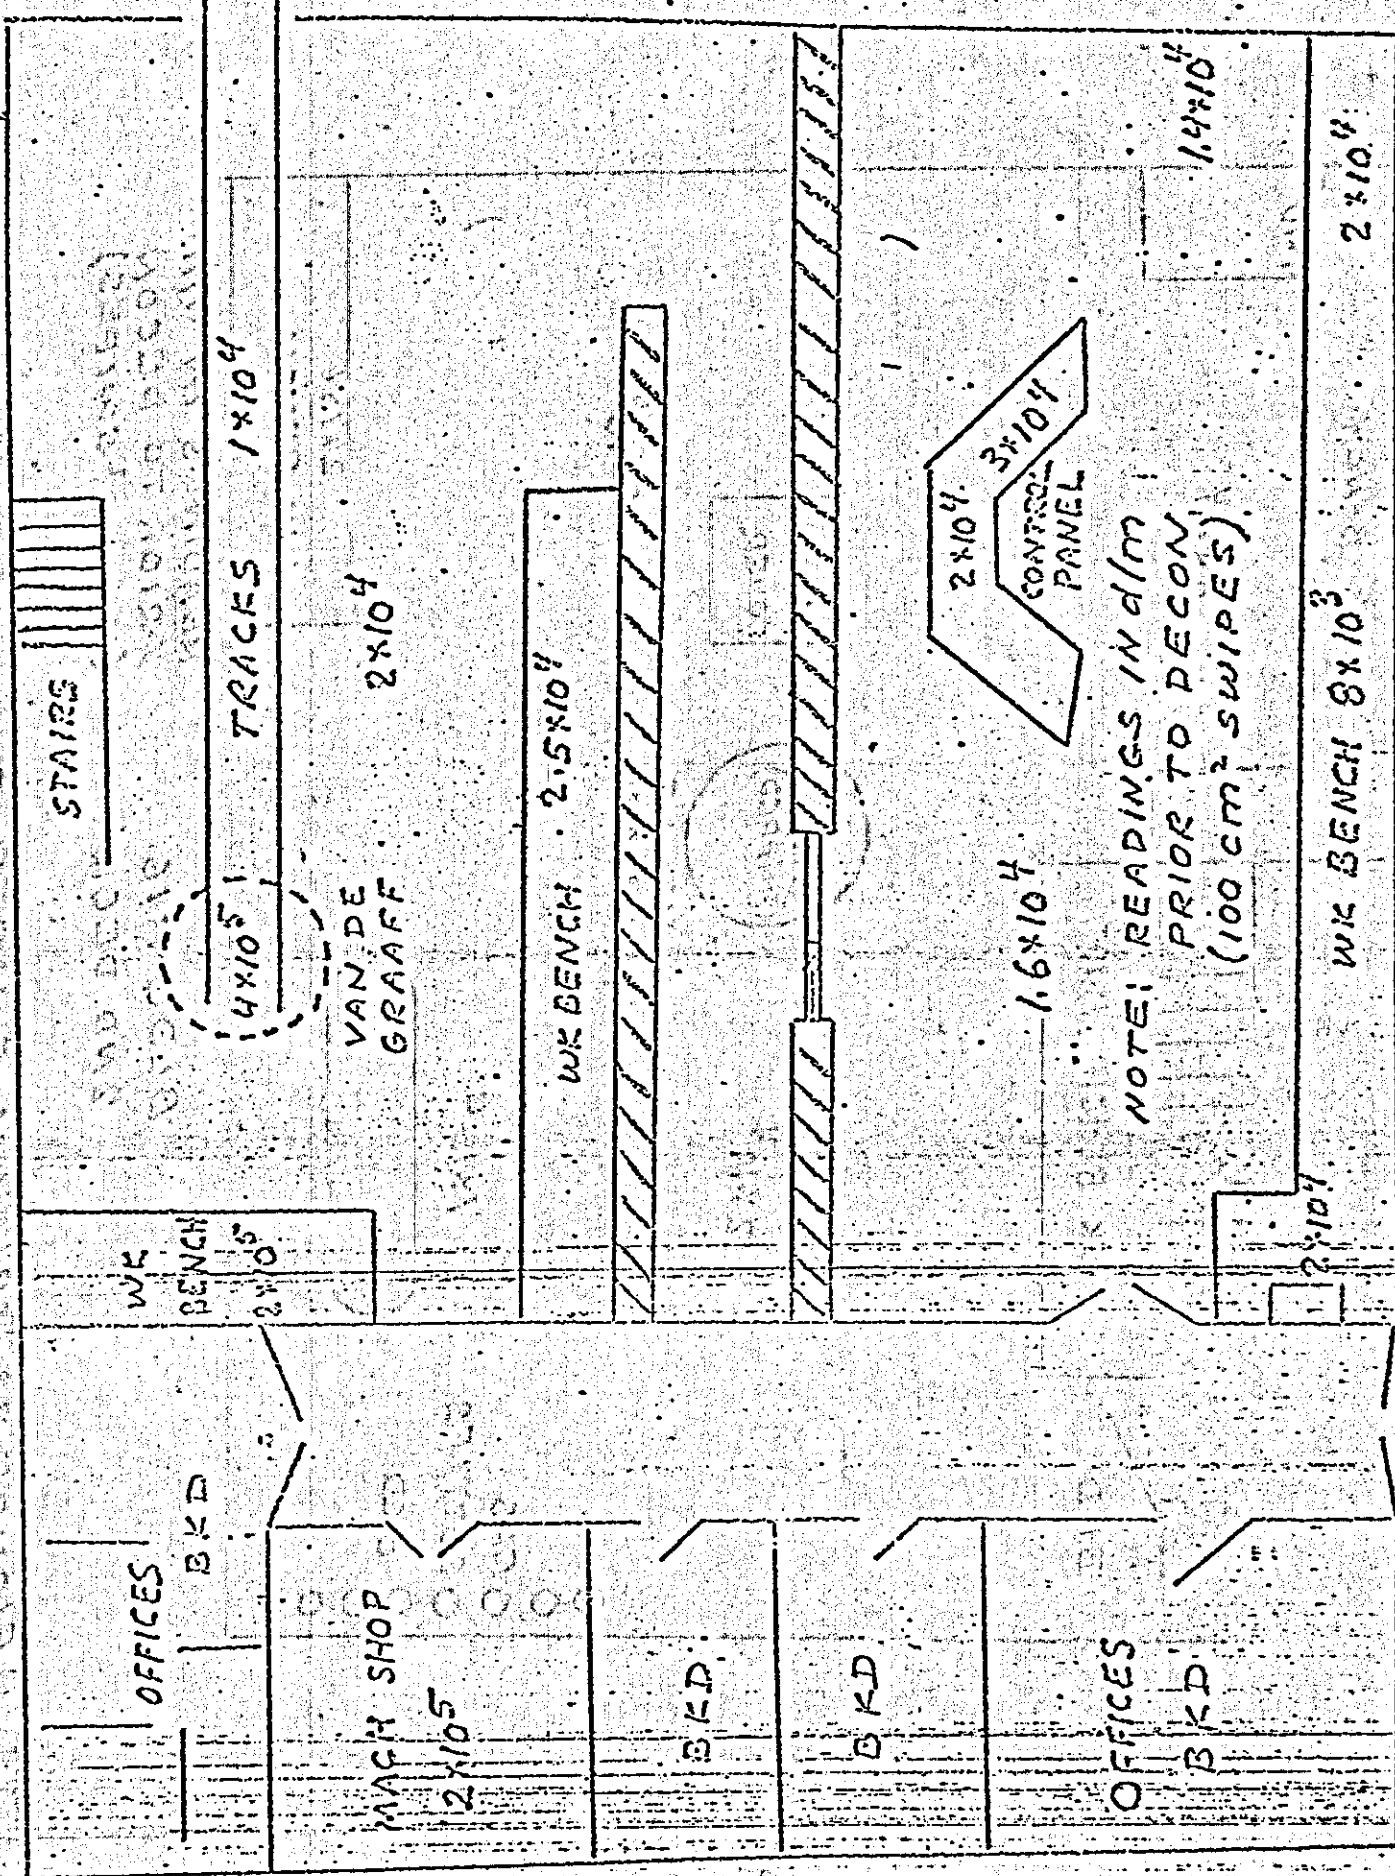
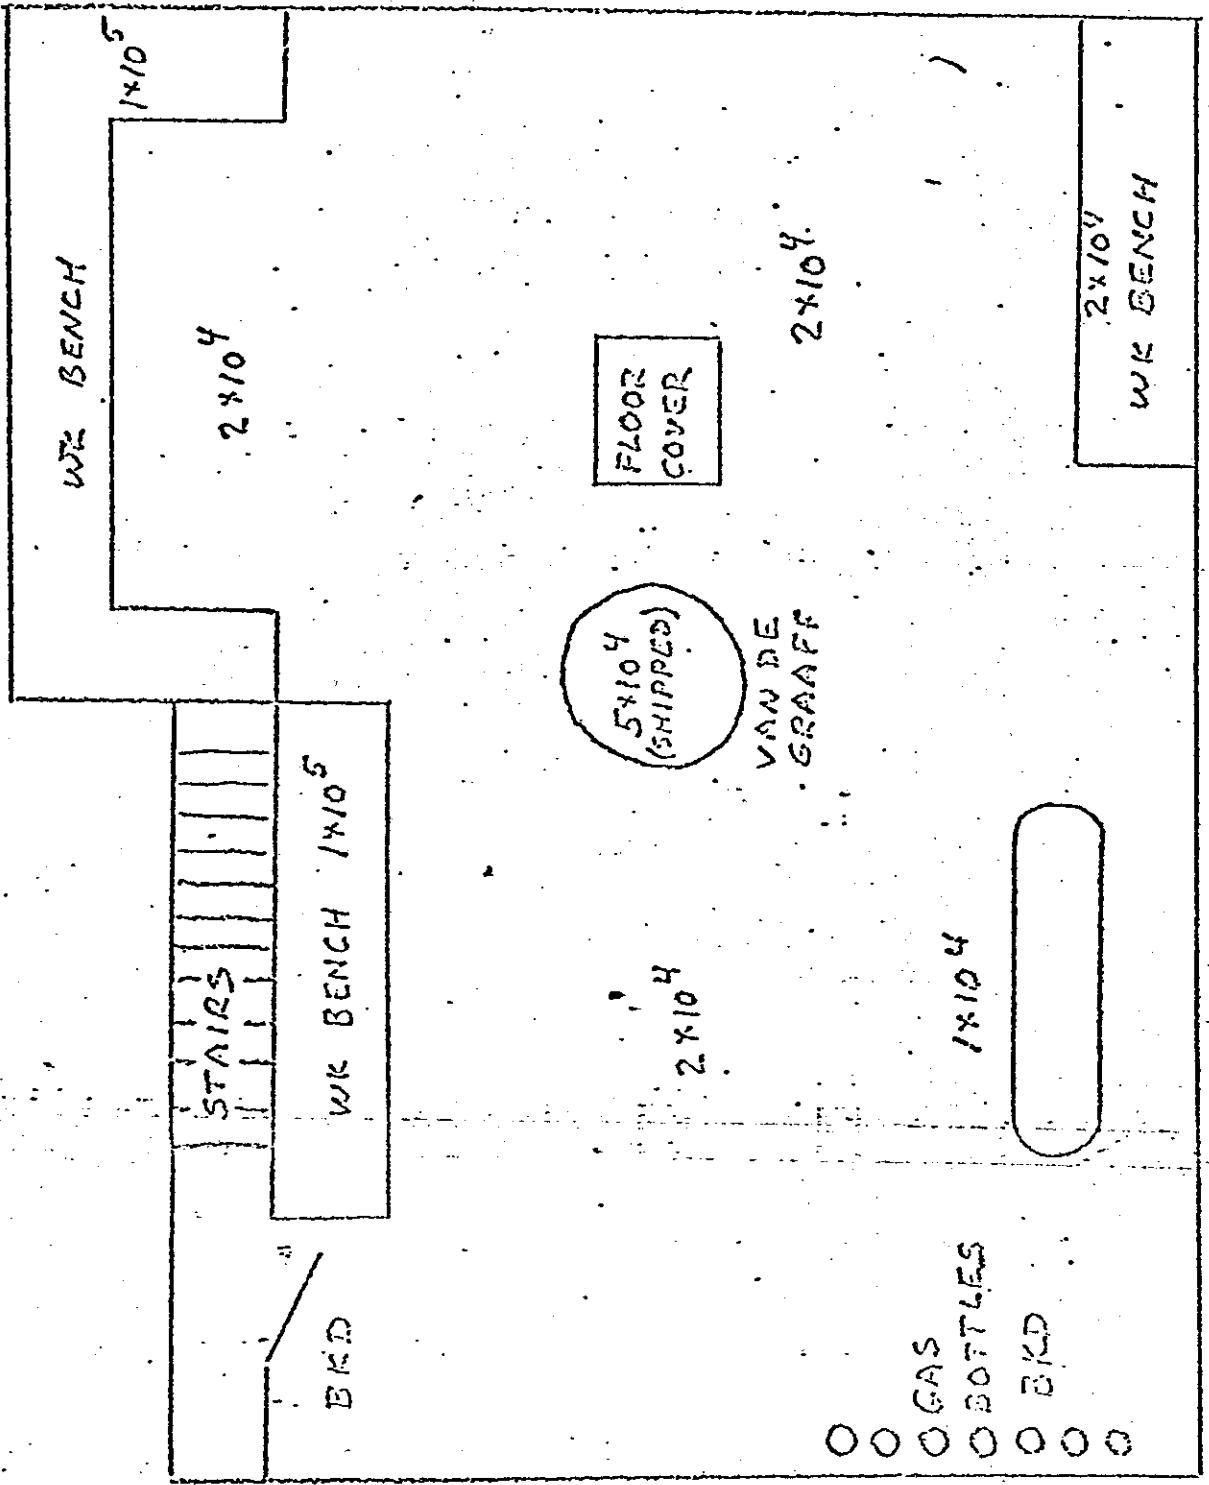
BLDG 816  
2ND DECK

READINGS IN d/m  
PRIOR TO DECOR  
(100 cm<sup>2</sup> SWIPES)
